Lessons learnt from collapse

Spencer Erling* (M) and Ron Watermeyer, (F)* discuss the causes of the collapse of a three-storey building in Roodepoort, South Africa

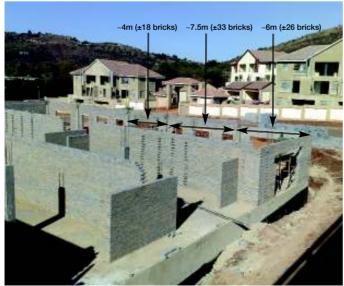
The photographs allowed the geometry of the slab and line of the collapse to be determined i.e., along the line of columns away from a construction joint in the slab, almost directly in front of where the

photographer took most of his pictures (Fig 1).

The spans of the slabs, which may be estimated by counting the number of bricks in the photographs (Fig 1) indicates that the slab panels have dimension of about $4\times6m$, $6\times6m$ and $7.5\times6m$. Likewise, based on the brick course height, the slab thickness is about 250mm (Fig 4). The thickness of the slab is much thinner than that recommended in terms of SANS 10100-1 for the design opted for. As a result, the deflection of the slabs would most likely to have been visible to the naked eye once the props were removed.

1 a) and 1b) Column spacing and brickwork

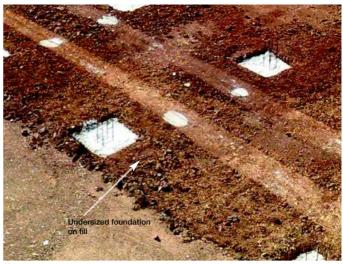
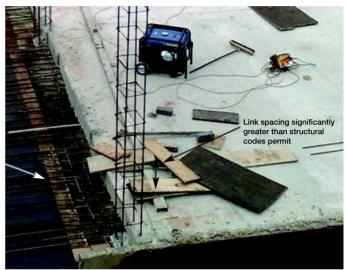
2b

The column bases, most of which are founded on fill, appear to be undersized for a three storey building. These under-designed bases could lead to excessive differential settlement which, apart from causing visible deflections, could redistribute the loads on the reinforced concrete members and in so doing reduce the load-carrying capacity of the slabs in certain areas (Fig 2). The spacing of the links in the columns is very much greater than that recommended in terms of SANS 10100-1, *The structural use of concrete – Part 1: Design*. The larger than allowed spacings of the links could result in the columns splitting vertically when being highly stressed (Fig 3).

Little or no top slab reinforcing steel was provided. Such reinforcement provides rigidity to the beam slab connection, shear resistance in the vicinity of the columns and bending resistance in the slab zones on the columns grid lines. (Fig 3). As a result, the beam / column connection is not a robust one, the slab resistance to punching shear was reduced and the slabs are unlikely to behave as flat slabs as no moment transfer can take place between panels. (This arrangement increases the central bending moment of the slab and prevents loads in one panel being distributed across to another panel. Whilst seldom used, as it is uneconomic, this situation can be designed for by increasing the bottom steel area and increasing the depth of the slab. Additionally, the designer would also, however, have to carefully assess the wall loads which were not on grid lines.

- a) Foundation slabs, b) Detail suggesting undersized foundations on fill
- a) Reinforcement in slabs: no top steel in slab visible, b) Link spacing significantly greater than structural codes permit

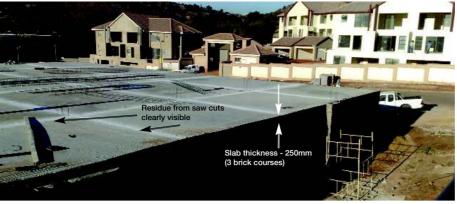
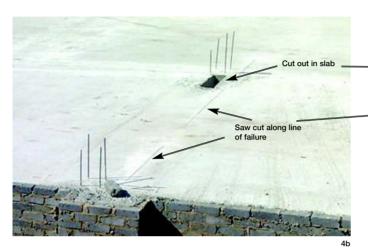
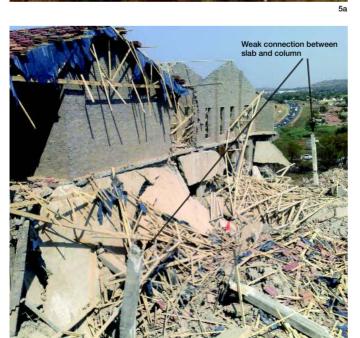
The combination of a saw cut and little or no top reinforcing steel over the column lines is a catastrophe waiting to happen. The slabs broke along the saw cut lines and collapsed showing the typical yield line breaks that are characteristic of the applied loads exceeding the resistance capacity of the slab (Fig 5). The columns, most of which were still standing after the failure confirm that the slab / column connection was not robust and that the slabs, as opposed to the columns, had failed.

- a) Saw cuts in slabs: residue from saw cuts clearly visible, b) Detail showing saw cut along line of failure, c) Detail showing saw cut along line of failure, straight break along line of saw cut and bottom steel holding slab in place
- a) Photographer's building, b) Balcony from which the photos were taken prior to the collapse, c) Collapse showing weak connection between slab and column, d) and e) The human cost of the collapse
